CHECK FOR BAD CLU SEAL

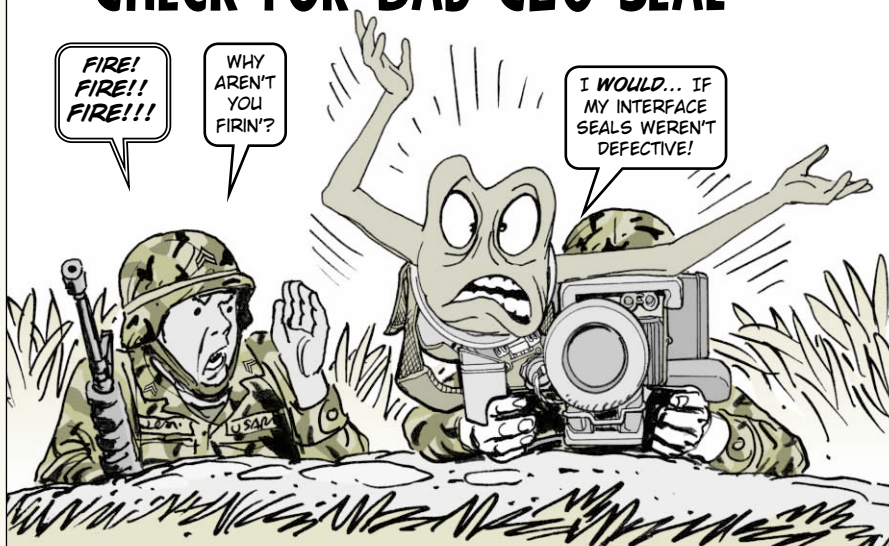
Defective interfacial seals for the Javelin missile system's command launch unit (CLU) round interface connectors have gotten into the field. The seals begin to come apart after only a few uses of the CLU, causing BIT failures and no communication between the CLU and the field tactical trainer or the Javelin round.

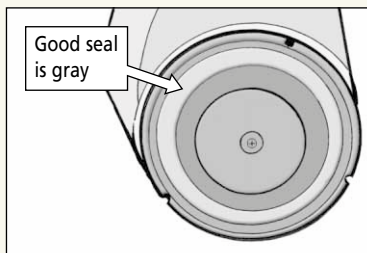
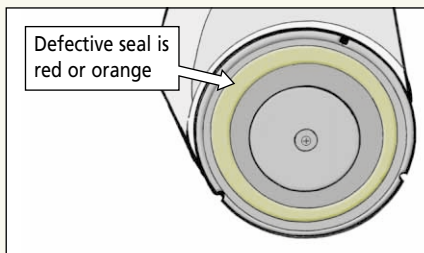
All Javelin units should immediately check all CLU round interface connectors—including spares—for the defective seal. Remove the protective cap from the connector and check the seal between the outer sleeve and the green barrel plug. If the seal is gray or translucent, it's OK. If the seal's red or orange, it needs to be replaced.

Tag the connector as defective and order a replacement connector through JAVTRAK, the Javelin requisitioning system, with NSN 5935-01-474-6361. After June, 2003, order the seal through the normal supply system.
